Manhole Inspection Summary

Manhole # S33QQ1003MH

Location Address: **WINSTON AVE**

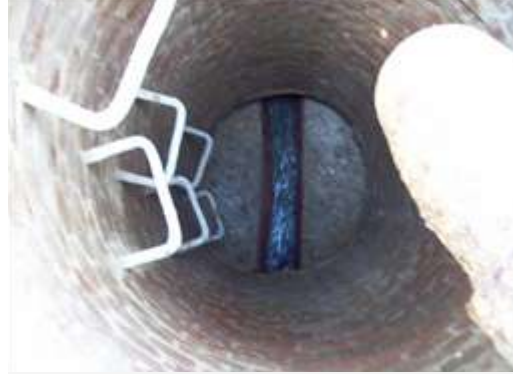
Top View

Barrel infiltration. Bench debris.

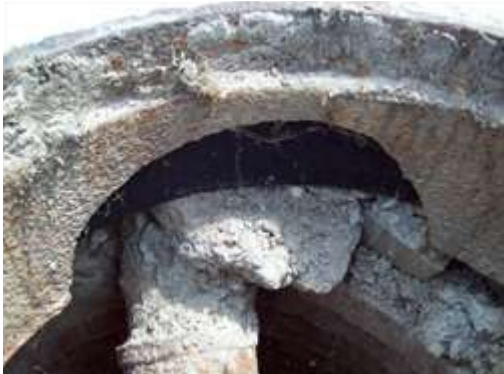
Defect

Broken Frame. Frame leaks. Adjustment deterioration and infiltration.

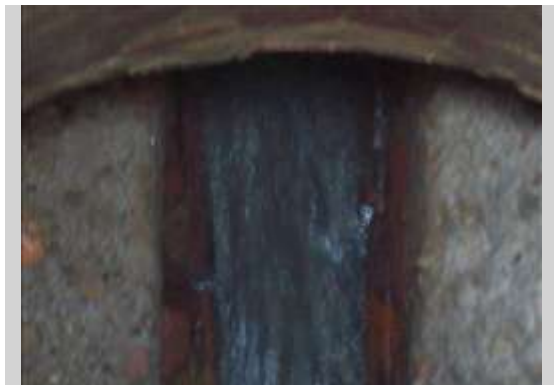
Pipe Out @ 12 O'Clock

Infiltration: **Evidence** Pipe Seal Cond: **Unknown**

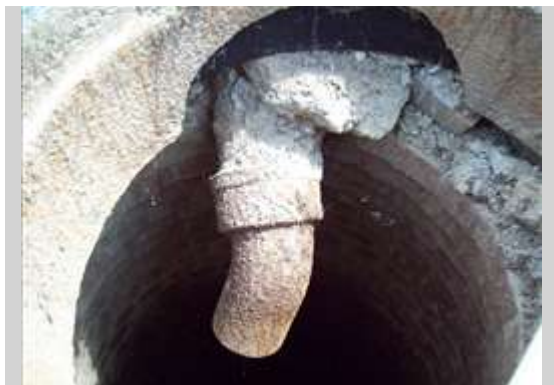
Pipe In @ 5 O'Clock

Infiltration: **None** Pipe Seal Cond: **Broken**
